MONUMENT RECORD  
State of Indiana - County of Monroe

Corner ID: Polk M-17

RECOVERY TIE DRAWING  
Field Book 33 Page No. 13

CERTIFIED LAND CORNER RESTORATION

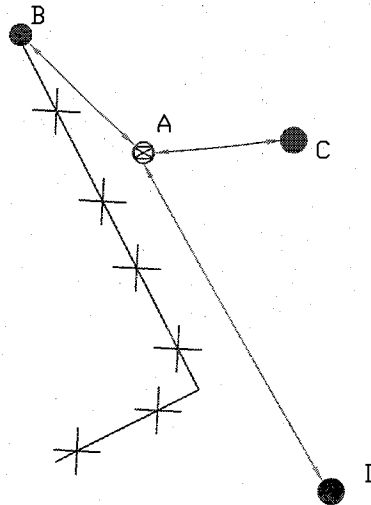
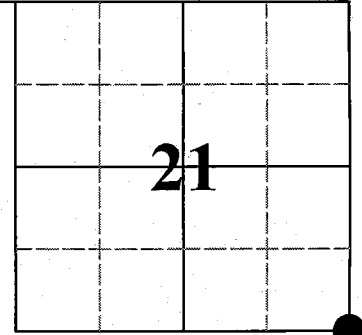
**Monument Description & Remarks:** 3" Brass Disk on aluminum pipe found. Survey Sign 3ft above ground at Pt. (B). Stone, with "+" found next to monument.

- A - 3" Brass Disk on aluminum pipe.
- B - N 67° W 3.58' to PK nail  
in 12" Black Walnut.
- C - N 53° E 5.25' to PK nail  
in 17" Yellow Poplar.
- D - S 36° E 27.25' to PK nail  
in 15" Chinquapin Oak.
